# Manhole Inspection Summary

Manhole # S09WW1011MH

Insp Date: **8/1/06 10:00 AM**

**Location** Address: **5510 KEN OAK RD**

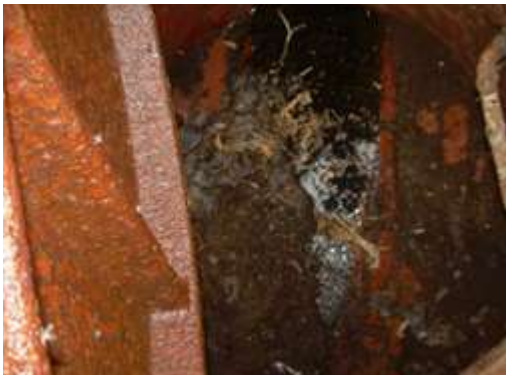
Top View

☒ **Evidence Of Surcharge** Depth: **3** (ft.) ☐ Active Surcharge Present

evidence of surcharge

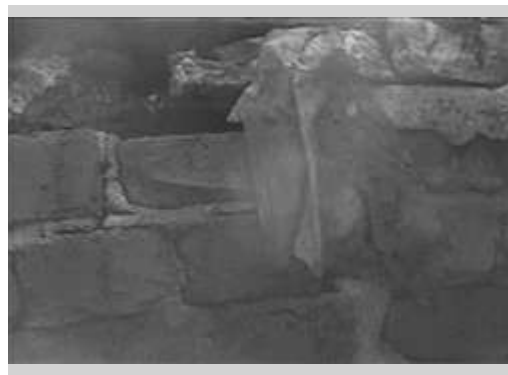
Defect

☒ **Debris** (not Condition related)

Condition: ☐ Sound ☐ Cracked ☐ Root Intrusion ☐ Deteriorated ☐ Leaks ☒ **Debris**

Channel debris

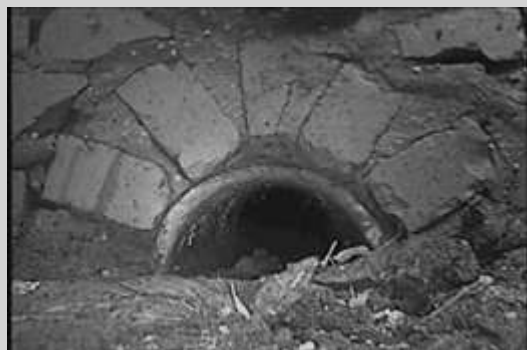
6 in. Circular Gravity Sewer

Pipe Out @ 12 O'Clock

Rod and Bar (Angled)

Deposits: ☐ None ☐ Mud ☐ Sludge ☒ **Debris** ☐ Grease

Silt Depth: **3** (in.)

Deposits Extent: **Heavy**

Infiltration: **Evidence**

Comments **O12 pipe needs cleaning.**
